July 25, 2016

RE: Arborist Survey for The Grove, Town of Loomis, Placer County, California

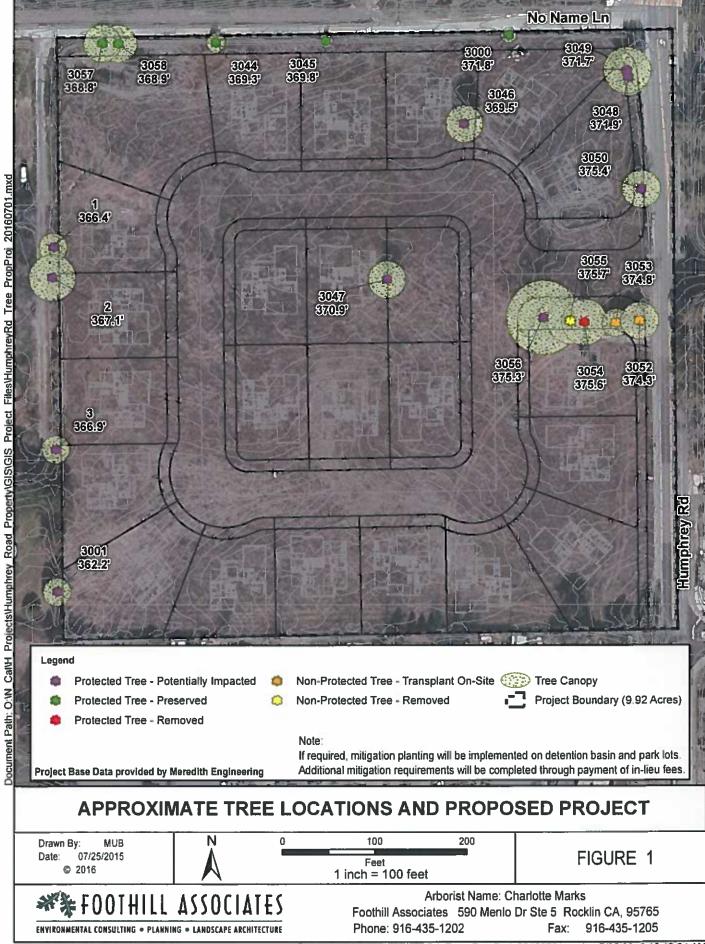
A total of 19 trees were surveyed within and surrounding the Project Site. Trees identified in the survey area include: eight valley oaks, six interior live oaks, three London planetrees, and two olives. Of the trees surveyed, 14 are protected oak trees under the Town Tree Conservation Ordinance, two are considered protected for planning purposes due to their large size, and three trees are not protected. Detailed tree data for all surveyed trees is included in **Attachment A**. The approximate locations of all surveyed trees and their driplines are shown on **Figure 1**.
